Site No. 20

SALTER GROVE

Warwick
Narragansett Parkway

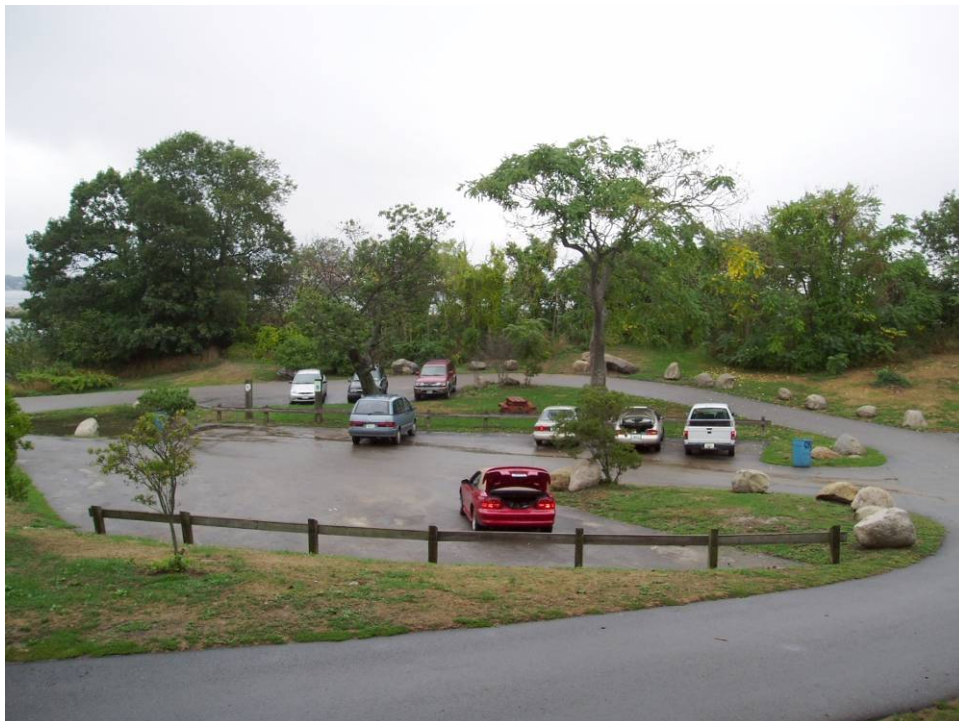
Photo 2. Salter Grove parking lot looking east.

A small paved parking lot for the park provides space for approximately 16 vehicles (including 2 handicap-designated spots), though it does not appear that vehicles with boat trailers are capable of parking within the site (Photo 2). This lot likely reaches capacity during times of peak use of the park, and while there is no parking along this stretch of Narragansett Avenue, on-street parking may be possible along the residential streets east of the site. Landside facilities (including a playground, several picnic benches, and trash receptacles within the parking lot) are excellent and appear to be well-maintained.

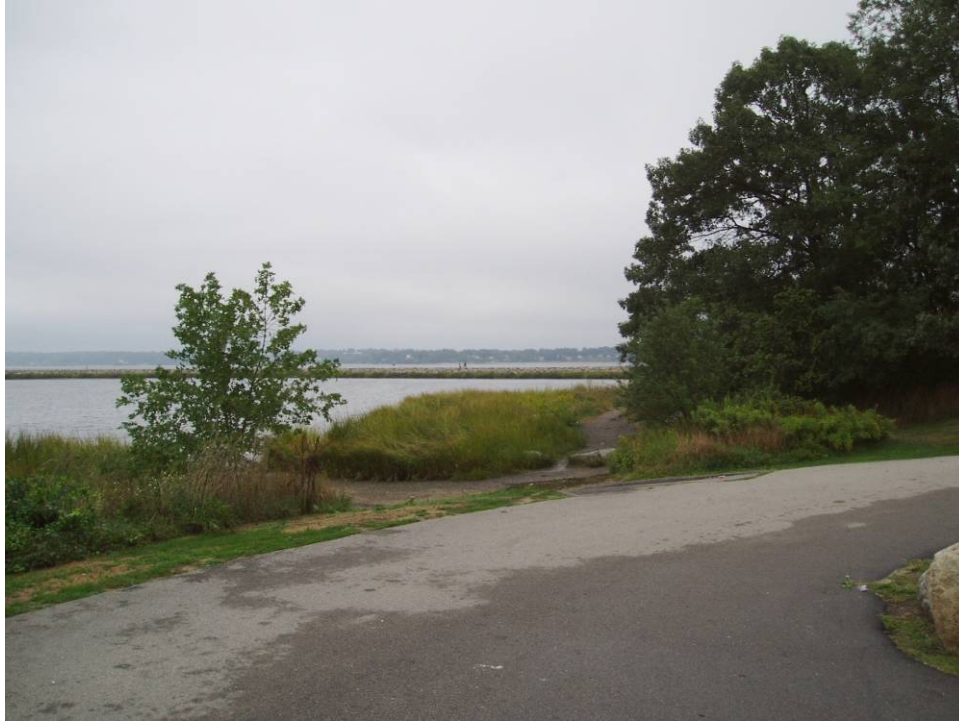
Photo 3. Path to causeway looking east from parking lot. The boat launch is to the left of the path.

Access to the breakwater is provided by an earthen causeway extending east from the parking area (Photos 3, 4, 7), which itself is sometimes used for fishing along the coves to its north and south (Photo 8). Like the breakwater, this causeway is characterized by difficult, irregular footing. In general, the surface condition of both features hinders the usability of the site by elderly individuals and families with young children, and all but prohibits fishing use of the site by persons with disabilities. These features also do not appear to be regularly maintained, as the aesthetics of the site are marred by a moderate amount of litter along the causeway and among the rocks of the breakwater.

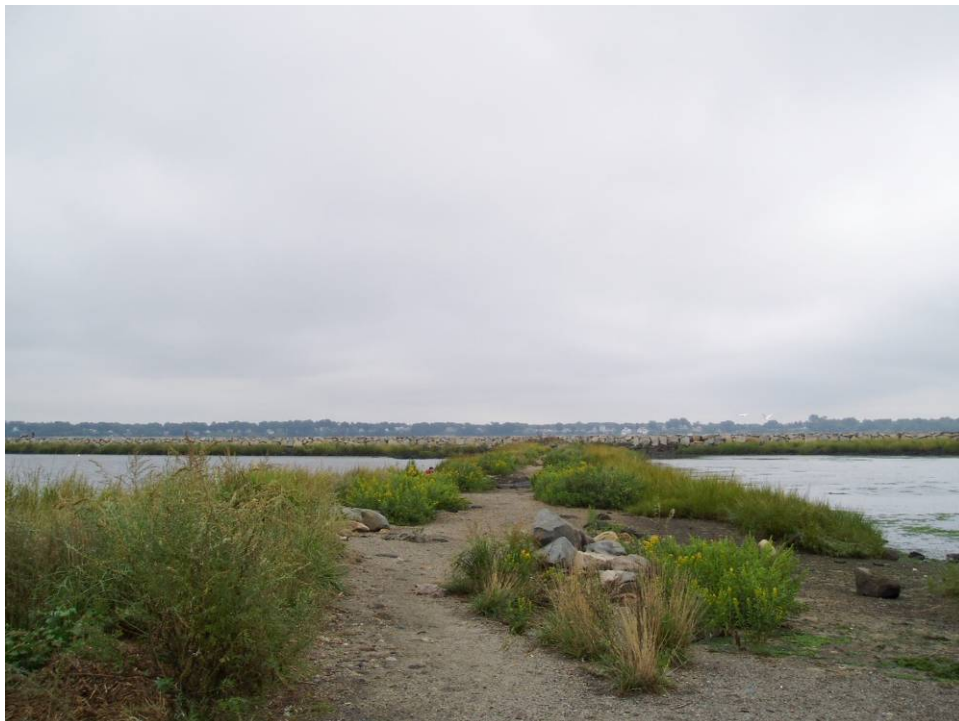
Photo 4. Looking east along causeway to breakwater.

Environmental Constraints and Permitting. Coastal features of the Salter Grove site consist of the rip rap breakwater and the fringe marsh which borders the causeway and interior sides of the breakwater (see Photos 4, 5, 6, 7). Providence River waters on the easterly side of the breakwater are designated by the CRMC as Type 4 (Multipurpose Waters). On the interior (westerly) side of the breakwater, waters within Pawtuxet Cove are classified as Type 3 (High-Intensity Boating), while waters to the south of the causeway are Type 2 (Low-Intensity Use). There are no known areas of eelgrass in the vicinity of the site.

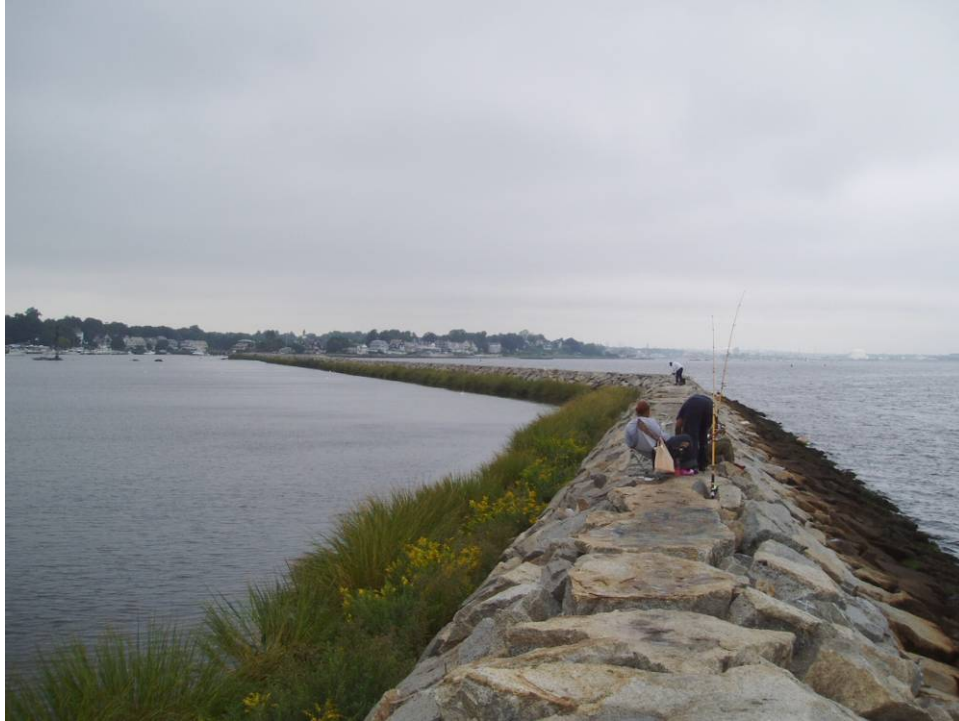
Photo 5. Recreational fishing looking north along breakwater.

As previously noted, fishing at Salter Grove is conducted primarily along the north-south breakwater constructed between Marsh and Rock Islands. While providing ample frontage for casting to the Providence River, current use of the breakwater is hindered somewhat by the difficult footing and narrow width of the top flat surface; bypassing an angler to access a spot further along the breakwater is a precarious proposition, particularly if the surface is wet (Photo 5). Waters along its easterly side are relatively shallow (see nautical chart image), though anglers interviewed at the time of site visit were satisfied with the quality of fishing access afforded by the structure.

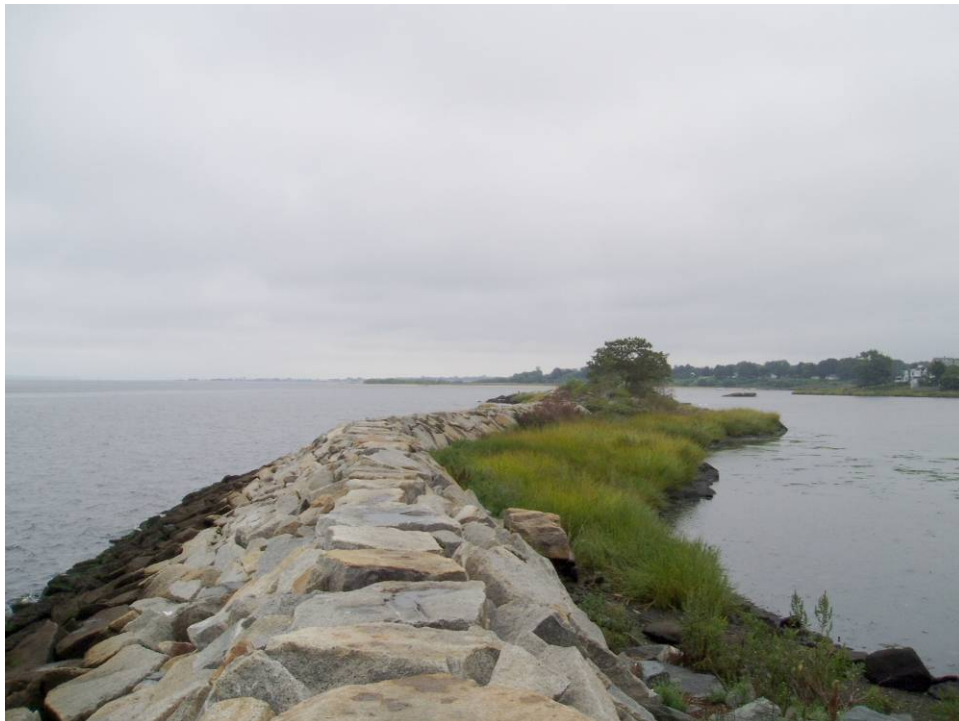
Photo 6. Looking south along breakwater to Rock Island.

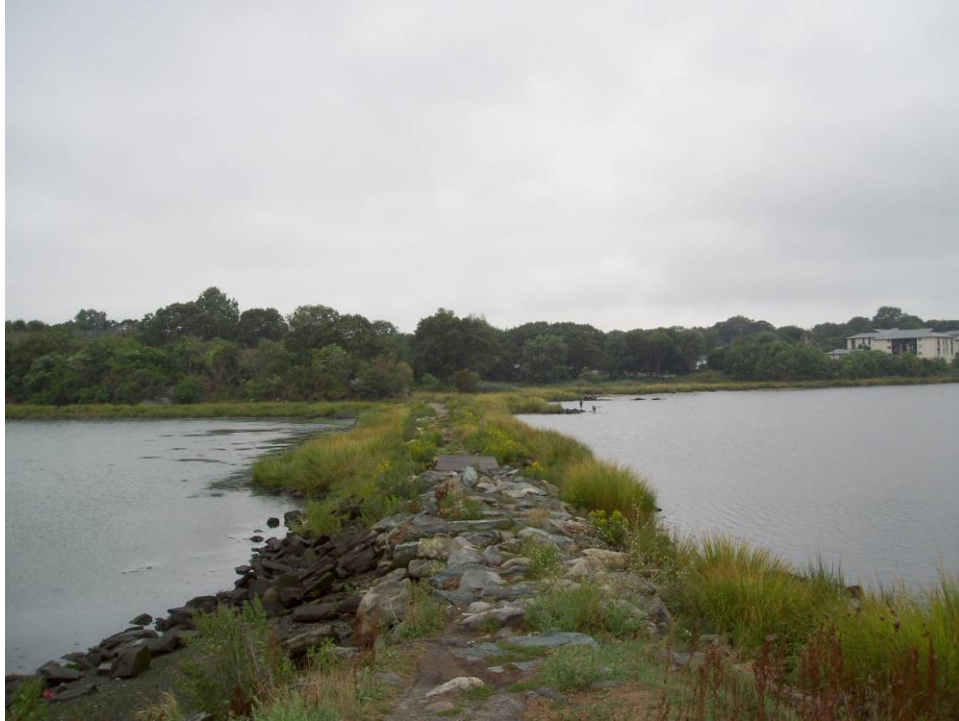
Photo 7. Looking west along causeway from breakwater.

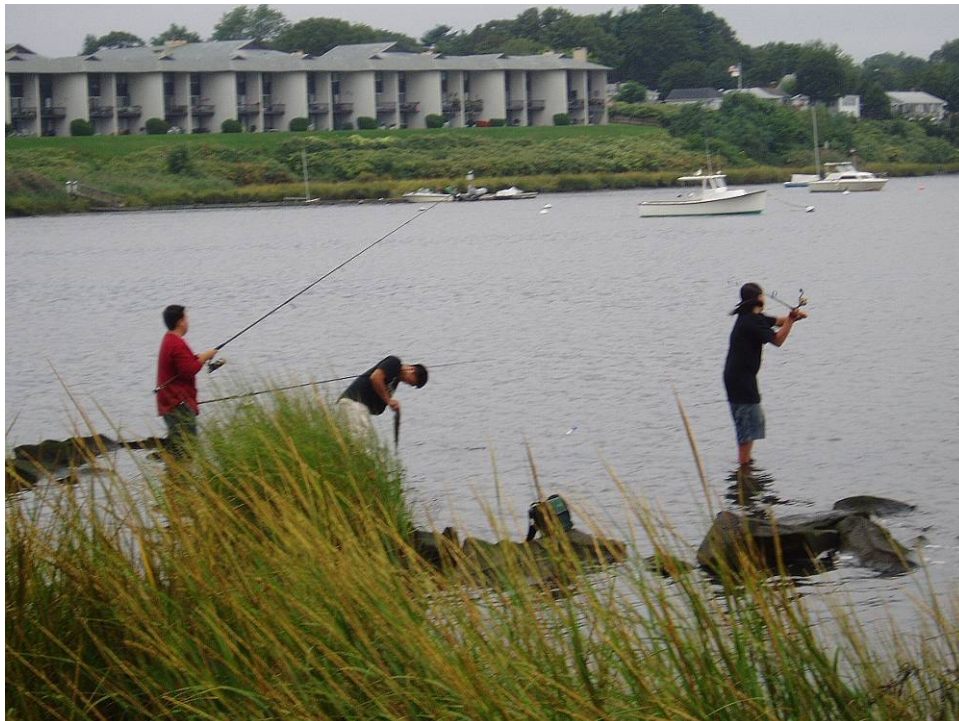
Photo 8. Recreational fishing within Pawtuxet Harbor (along north side of causeway).
